“New Acquired information pertaining to The Bethlehem Steel Site Profile”

Re:Rolling Procedures

HW-24849

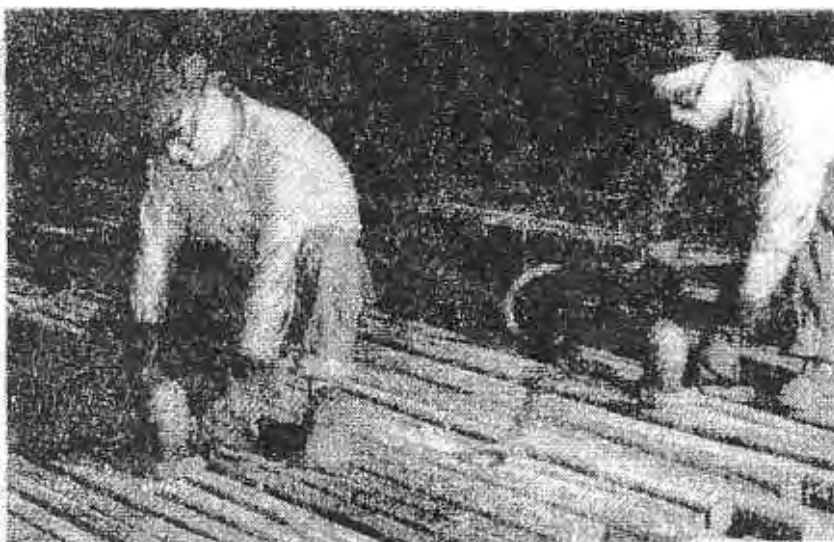
Left: Surface defects in billets are removed prior to further processing

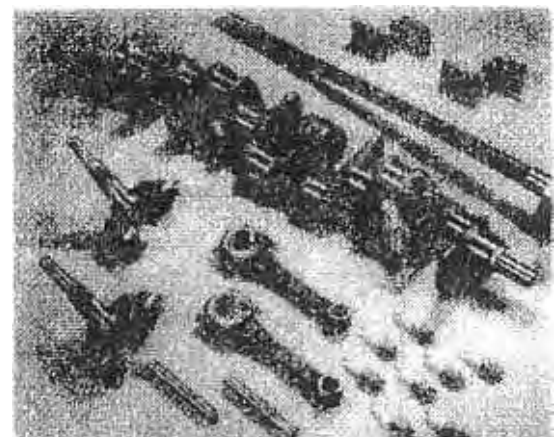
Right: Representative automotive parts made from bars rolled on the various bar mills at Lackawanna Plant
